Lifetime Durability of Ceramic PX™ Energy Recovery Devices

Energy Recovery Inc

September 2011

A White Paper on Long Life Materials for
Desalination Applications

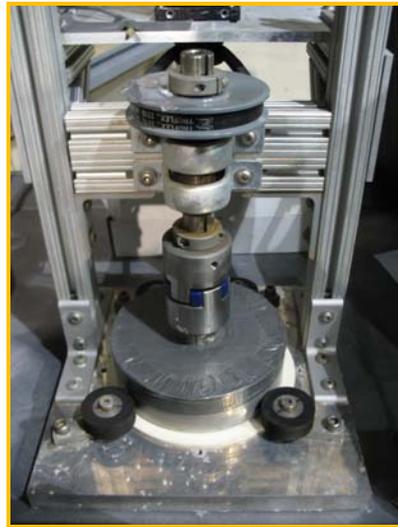
FIGURE 2. ERI Submersible “Pin on disk” Ceramic wear testing apparatus

ERI™ engineering regularly evaluates used components for physical wear. To complement this data, ERI developed materials testing capabilities. To date, quantifying the measure of wear of ERI ceramics using this test generates results that are undetectable; even when operated at almost 10 times the designed thrust load applied to the PX unit. ERI has been unable to quantify wear rates on ERI ceramics using this test since wear channels generated are within the limits of ERI test metrology; even when operated at almost 10 times the designed thrust load applied to the PX unit.

Studies suggest that friction couples made from ERI's ceramic materials, including our internally formulated ERI 998, wear at peak rates less than three microns per year (.003 inches over 25 years). This result is comparable to studies of biomedical alumina ceramics, such as "Bilox Forte" from Ceramtec, which indicates average wear rates of alumina ceramic couples in water can be as low as one micron per year¹. Since laboratory testing
